## LA-UR-19-28813

**Title:** Evaluating Corrosion Effects on the Stainless Steel Components of the SAVY-4000/Hagan Nuclear Material Storage Containers: FY19 Update

**Issued:** 2019-10-11 (rev.1)

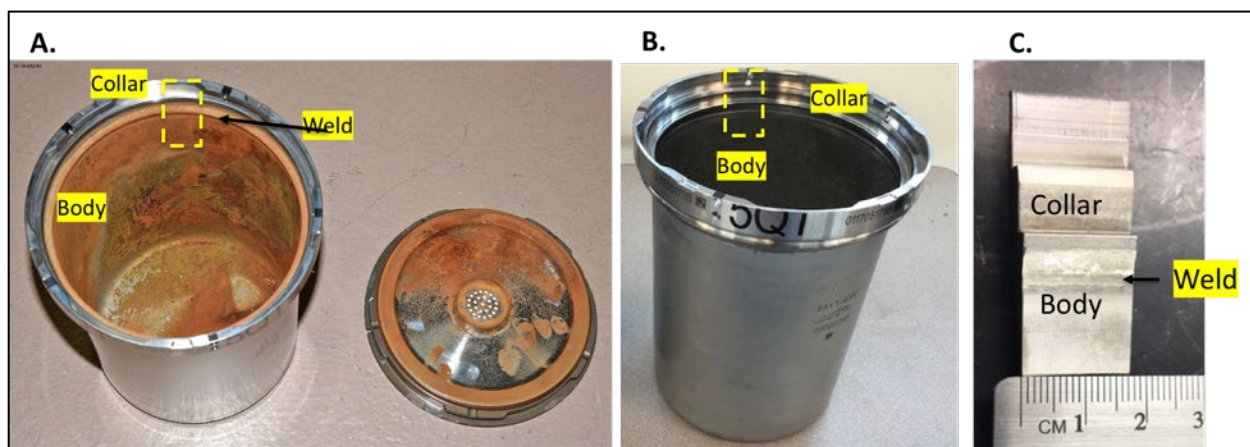
In FY19, SAVY-4000 container 011305020 was cleaned and sectioned to obtain approximately twelve 17 mm × 6 cm samples from the top of the container as shown in Figure 17.<sup>17</sup> The dashed yellow box in Figure 17A represents the approximate area of a single section.

**Figure 17. A. Photographs of container body after unloading. Picture taken from LA-UR-18-25709. B. Photographs of container body after cleaning. C. Small SAI section.**

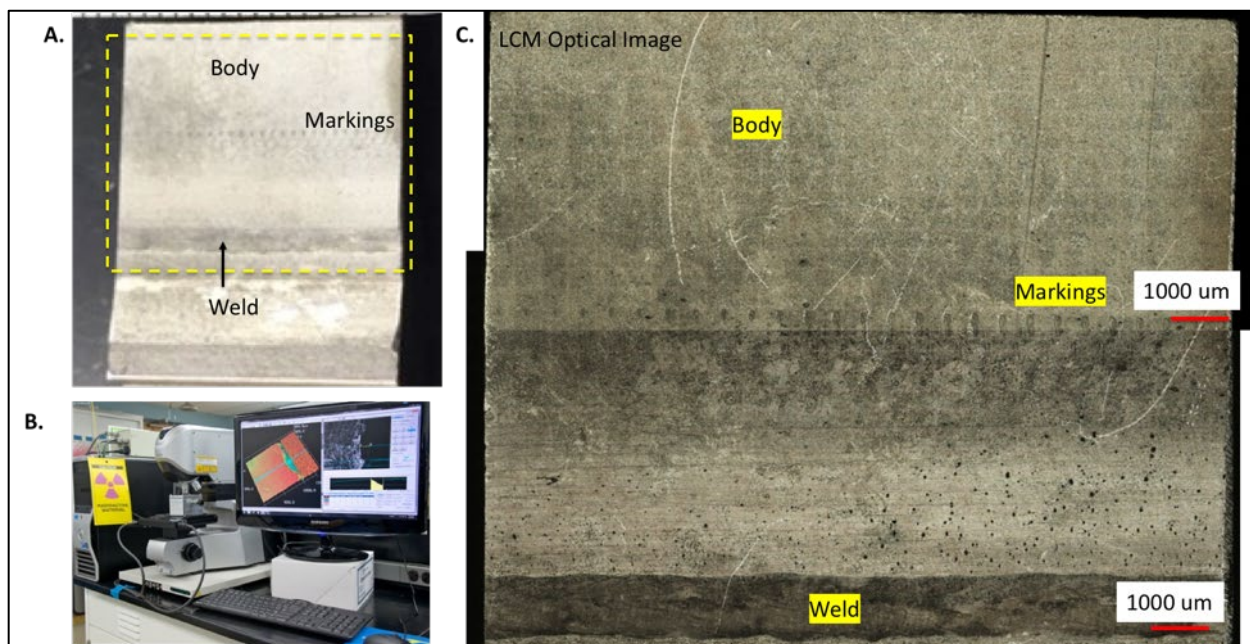
**Figure 18. A. photograph of the characterized SAI section. B. Photograph of the Keyence Microscope. C. Surface image obtained with the Keyence instrument.**

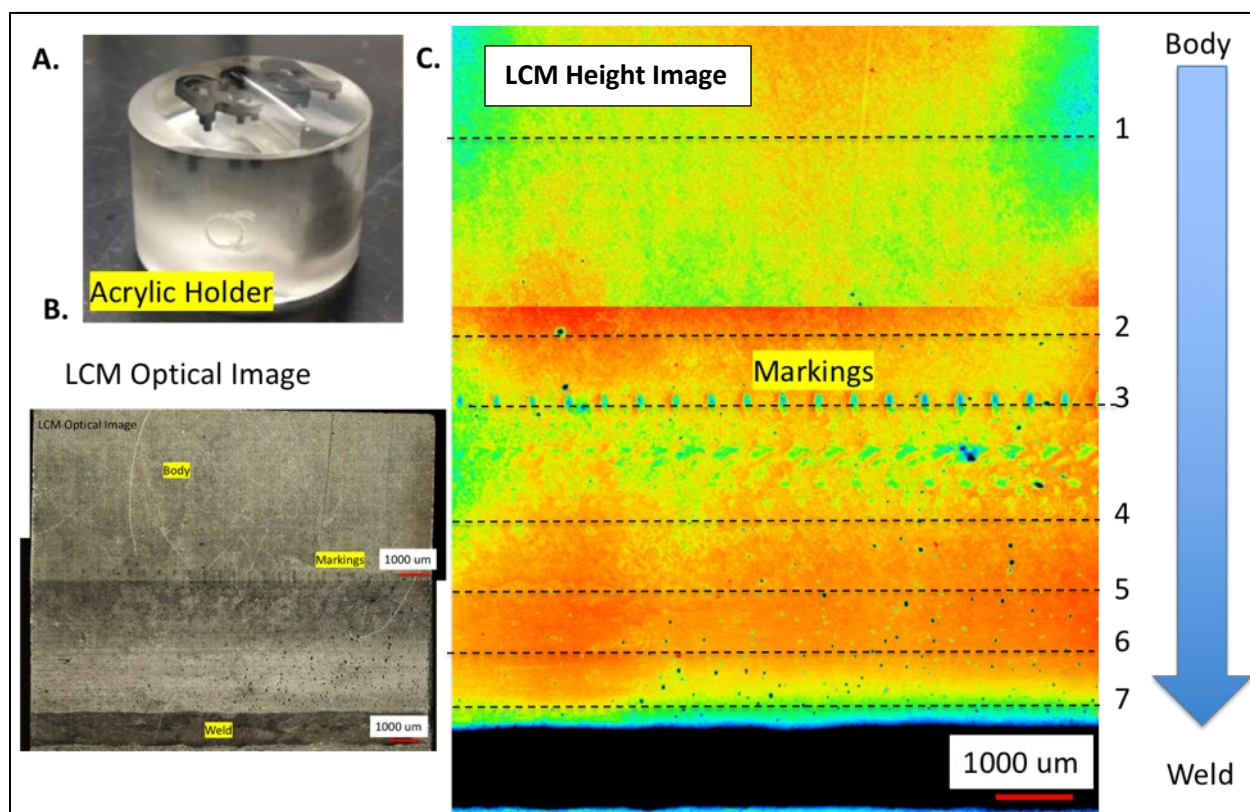
**Figure 19. A. Photograph of the acrylic holder with the SIS section. B. LCM optical image of the SAI surface. C. LCM height image of the SAI sample with the pre-determined areas where cross-sectional analysis was performed.**

Examination of the height data collected on the surface of the SAI sample (Figure 19c) found pitting with a pit depth distribution ranging between 5 and 60 microns (Figure 20). The region with the highest density of pits is located near the weld, as shown in Figure 19.

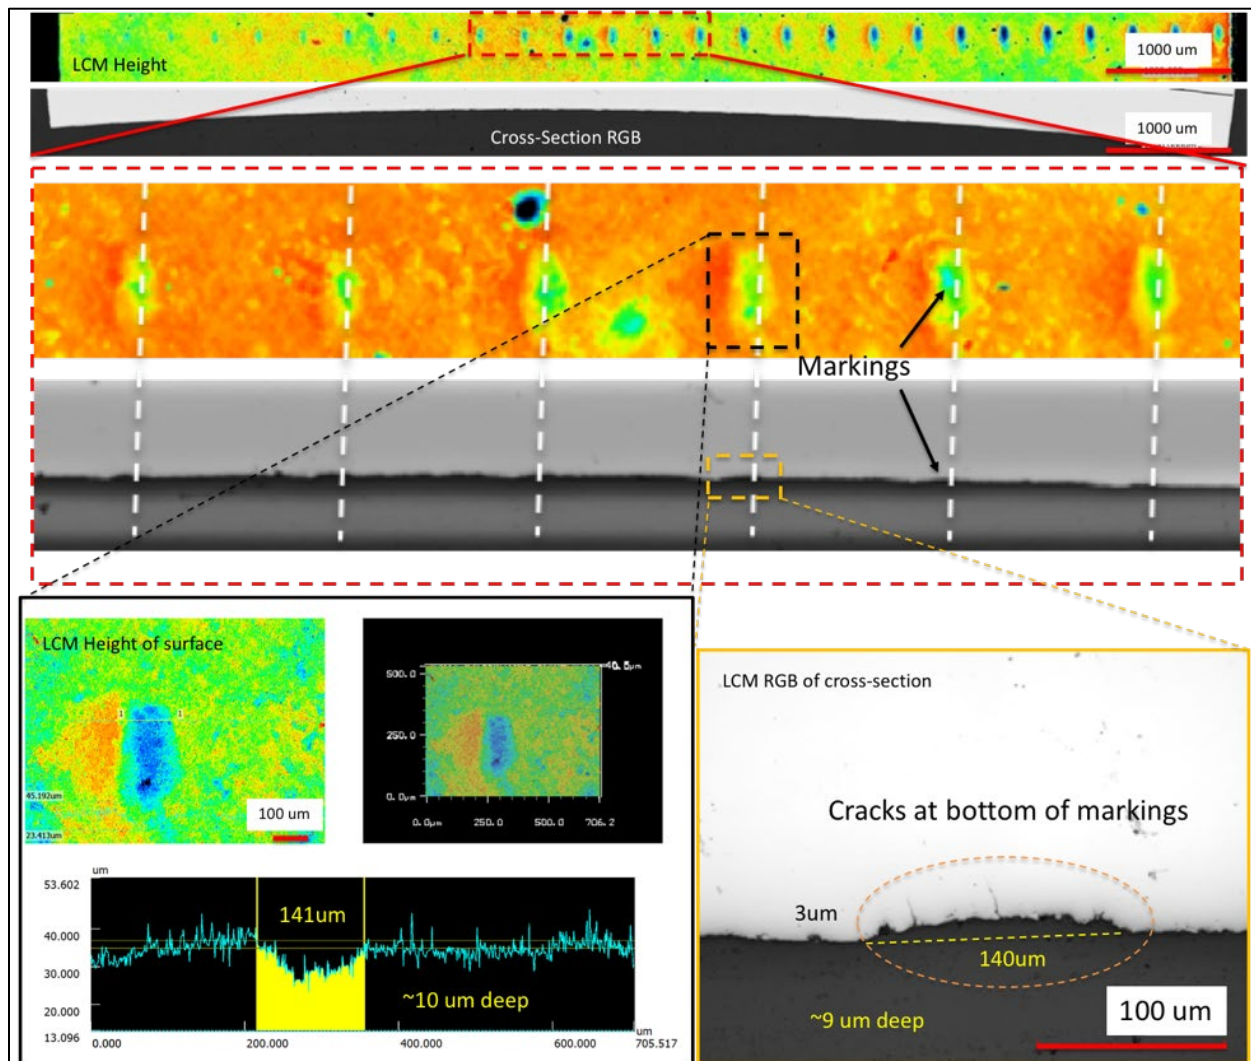
A critical aspect of this work is to develop correlations between the surface image and sub-surface profile. Figure 22 shows the relationship between the surface image with unique markings on the surface of the sample, and cross section sample 3 as shown in Figure 19. A good correlation was observed between the surface features and the sub-surface features, which include shallow pits up to approximately 10 microns in depth and 140 microns wide shown in the black and orange boxes below. Interestingly, the sub-surface profiles reveal some small cracks at the bottom of these markings. The origin of these markings is unknown and are only seen in this container. At this time it is impossible for us to know if these cracks were a result of the corrosion or the marks themselves.

**Figure 22. Representative LCM ensemble images of the surface (height data) and cross-section (sub-surface). Red dotted box is a zoom of the ensemble to highlight correlations. Black and orange boxes are higher resolution images of the ensemble to show small features profiles.**

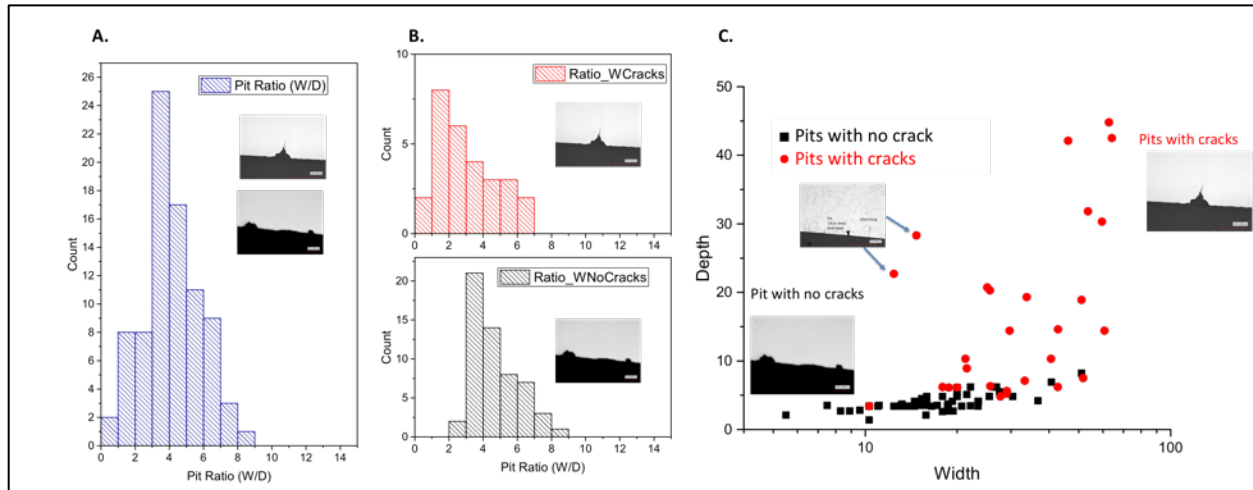
The aspect ratio (width/depth) of the pits in Figure 23 was measured using LCM images. The measurements show that the width of pits without cracks is 4 times that of the depth. Pits with cracks have a smaller aspect ratio. Figure 24C shows a graph of the depth versus the width shows a nearly exponential increase in the depth due to the cracks. These results suggest that the pits that have cracks at the bottom of the pits nearest the weld are getting deeper at a much faster rate than those away from the weld.

**Figure 24. A. Width/depth aspect ratio for all pits. B. Width/depth aspect ratio histogram for pits with cracks (red) and pits without cracks (black). C. Correlation between depth and width for the pits with cracks (red) and pits without cracks (black).**

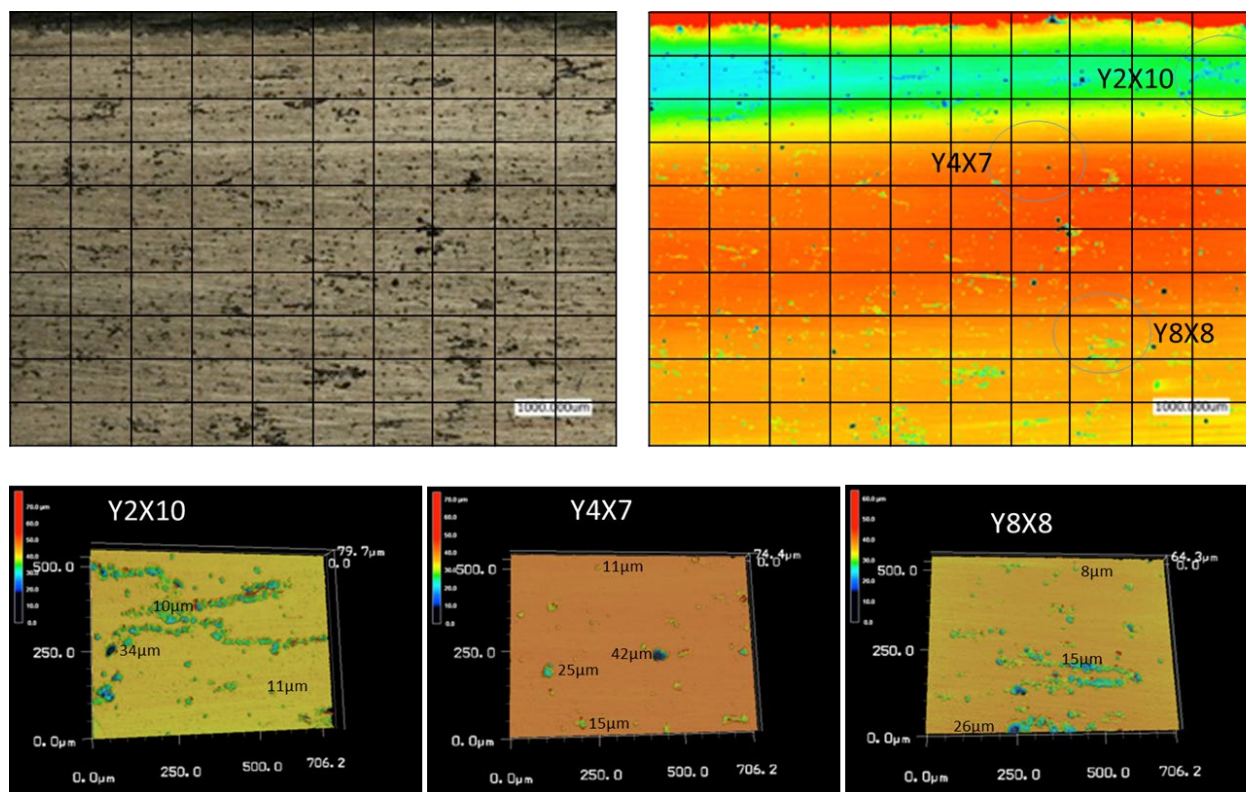
For the SAVY-4000 container, an increase in corrosion density was measured on the container wall with increasing exposure time. The corrosion is isolated to corrosion “islands” and does not cover the entire surface of the container, and it is not greater at the weld area. Similar corrosion was also observed in the exposure of teardrops (stainless steel samples) to 6.0M HCl vapors.<sup>20</sup> The corrosion observed on these SAVY-4000 container test specimens is shown in Figure 29. These samples also have isolated corrosion “island” and general corrosion covering the entire surface of the sample, which was not observed on the container wall. Surface analyses after cleaning found surface corrosion and uniform pitting on the entire surface of these samples (Figure 30). Increasing exposure time to HCl vapors did not significantly result in an increased number of pits on these samples, and only a small increase in pit depths was measured.

**Figure 30. Representative optical stitched (top left) and height stitched (top right) images (10x10) of the SAVY-4000 corrosion specimen exposed to vapors from 6.0M HCl for 31 days. Images show a uniform pit distribution. Height images (bottom) show isolated and agglomerated pits of different depths. The remaining corrosion specimens have similar uniform pit distribution (images not shown).**

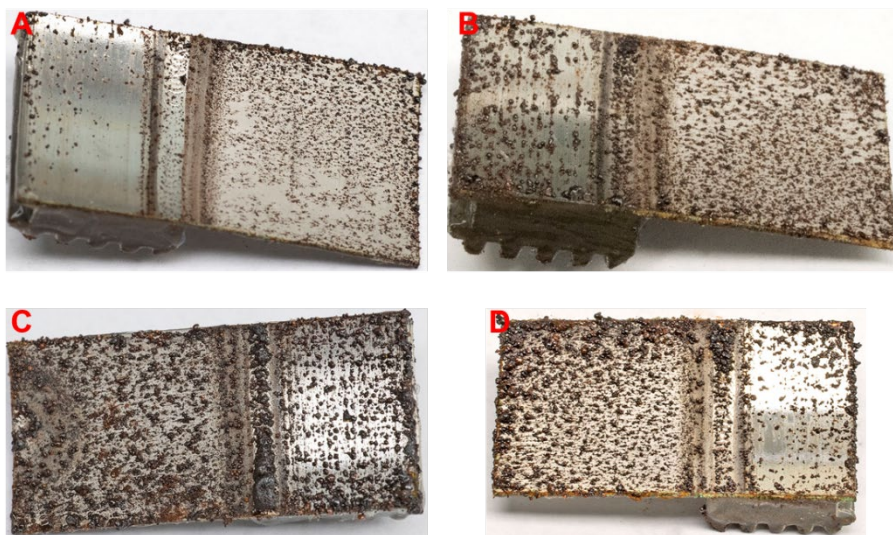
Similarly, a Hagan container and four corrosion specimens were exposed to the vapors from 6.0M HCl. The photographs show an increase in corrosion density on the container wall with increasing exposure time. The corrosion is also isolated to corrosion “islands” but in this case, there is more surface coverage compared to the SAVY-4000 container. Surface analyses by LCM on the container wall are currently ongoing. The Hagan container test specimens showed similar corrosion to what was observed on the container (Figure 31). Surface analyses after cleaning found surface corrosion, and pitting on all of the samples, with corrosion cracks observed on the samples removed after 95 and 126 days of exposure. The pits and cracks were observed in the heat-affected zone (Figure 32). Increasing the exposure time in these samples increased the number of pits, and the pit depths as shown in Figure 33.

**Figure 31. Photographs of Hagan corrosion specimens after exposure to vapors from 6.0M HCl for 31 (A), 63 (B), 95 (C), and 126 (D) days. Photographs show the presence of corrosion “islands” which are also present in the container.**

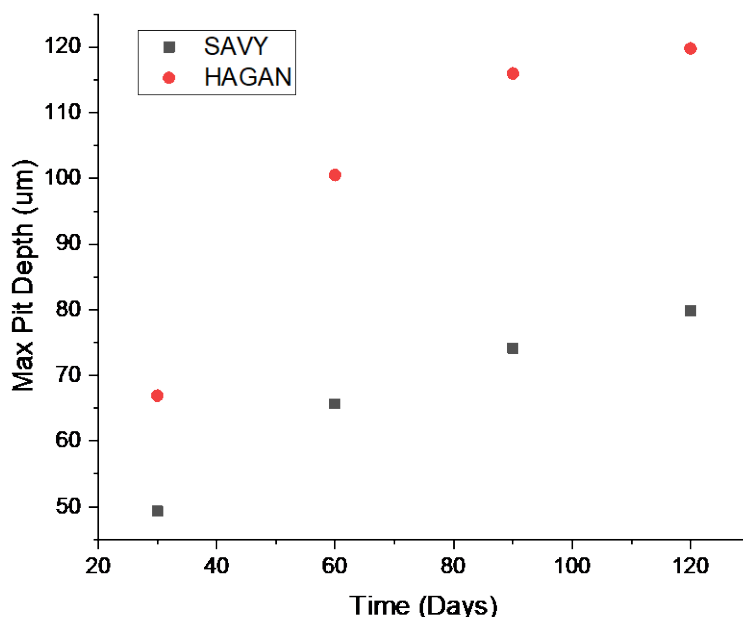
Preliminary results from these studies seem to confirm that Hagan containers are more susceptible to pitting and cracking when exposed to HCl in a moist environment based on the observations of cracking in the Hagan container test specimens. Additionally, Hagan containers have higher rates for pitting than SAVY-4000 containers under the same conditions as shown in Figure 33.

**Figure 33. Maximum pit depth of SAVY-4000 (black squares) and Hagan (red dots) as a function of time for container test specimens.**

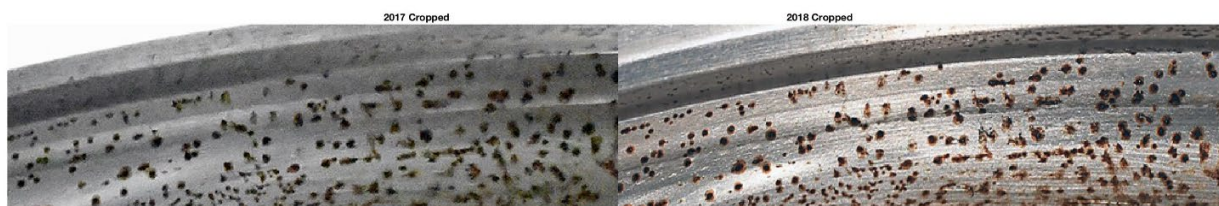
One application of the software is to determine the amount of corrosion on an image based on the area of the features (dark spots on the images in the Figure 39) and compare areas over time. Figure 1 shows photographs of a section of a SAVY-4000 photographed in 2017 and 2018.

**Figure 39. Photographs of the same section of a SAVY-4000 lid taken in 2017 and 2018. Comparisons of the amount of corrosion were made using the automated software.**

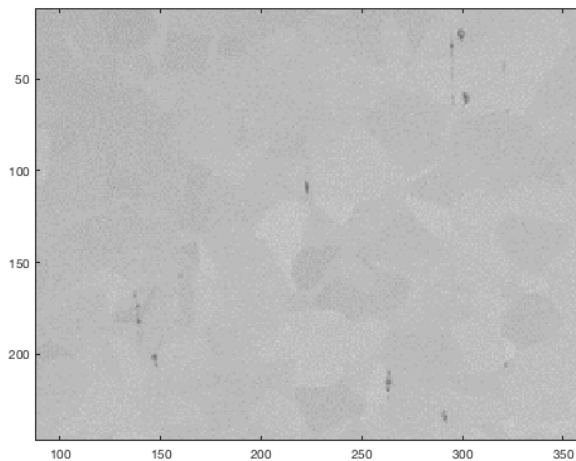
Figure 40 shows a photograph of a section of a SAVY-4000 container that has stringers. The areas estimated by the software were used to estimate the quantity of MnS in the material and were compared with SAVY-4000 specifications, which have a limit on the sulfur content. The software was also used to assess stringer density, as these channels could be initiation points for corrosion.

**Figure 40. SAVY-4000 container photographic image with the dark areas indicative of stringers containing MnS.**

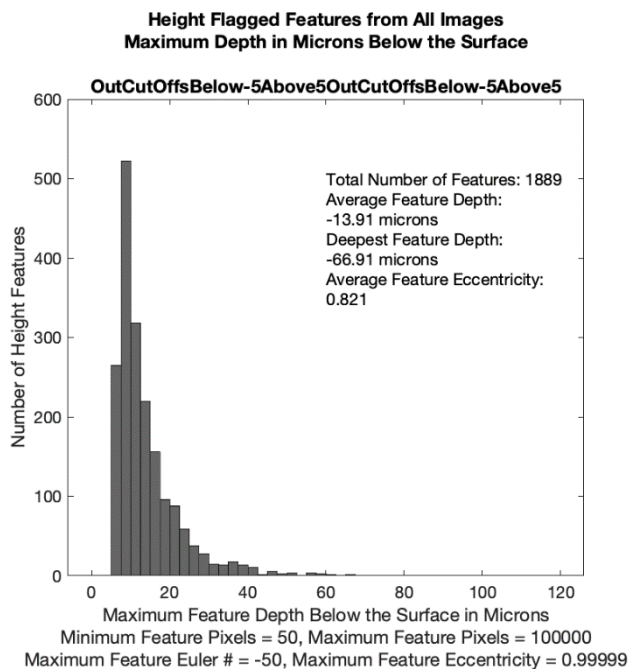
The automated software can be used to identify features such as pits and cracks. LCM image analysis can be human resource intensive and detecting very small potential cracks is challenging. The automated software makes these tasks more feasible for large numbers of images. Figure 41 shows the pit depth distribution generated by the software for height data from an LCM image, with observations below 5 microns excluded. The maximum depth, average depth and the eccentricity (roundness) of the features are summarized on the figure.

**Figure 41. Pit depth distribution for a piece from a Hagan container.**
